VEHICLE RETURN GUIDELINES

This damages catalogue aims to prepare you for returning your IVECO truck when your usage period comes to an end.

APPENDIX TO THE VEHICLE RETURN GUIDELINES

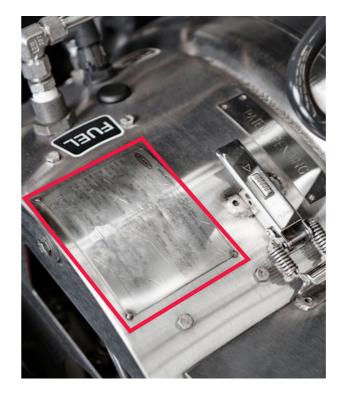
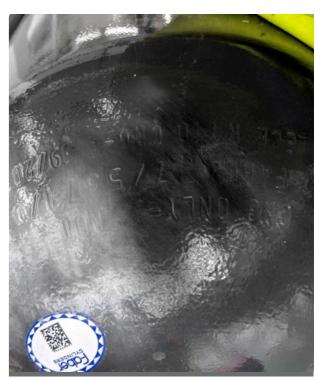
Original LNG tank and CNG cylinder identification markings absent or illegible \rightarrow charge for replacement of CNG/LNG tank with a new one.

Absence of an up-to-date validity certificate for the tanks \rightarrow gas certificate fixed charge of \in 1500 before tax.

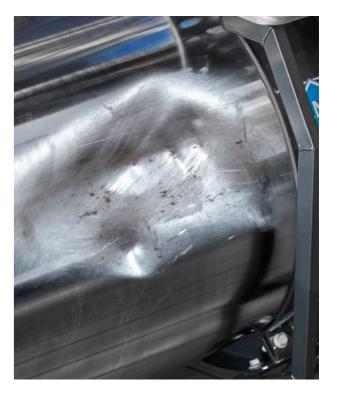
Evidence of tank repairs \rightarrow charge for tank replacement.

Tank holed → charge for tank replacement.

- Maximum depth of deformation ≤ 7 mm with no signs of frost or sweating → note without charge for damage (note in the expert report).
- Depth of deformation > 7 mm → charge for tank replacement.

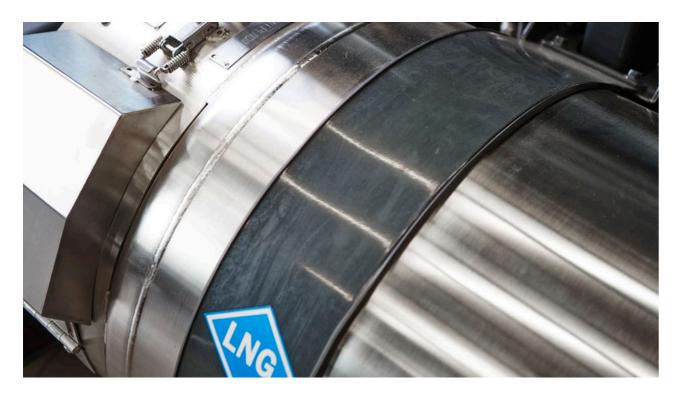
RETAINER BRACKETS AND BANDS FOR LNG TANK

LNG tank must be returned in proper conditions as illustrated in picture.

Check that the brackets and the bands are present and properly thighten.

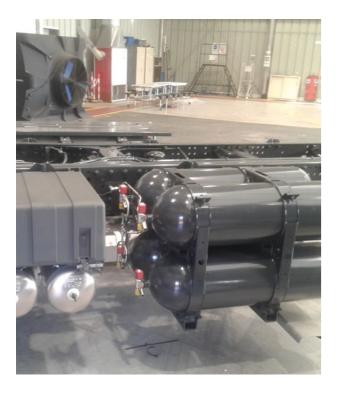
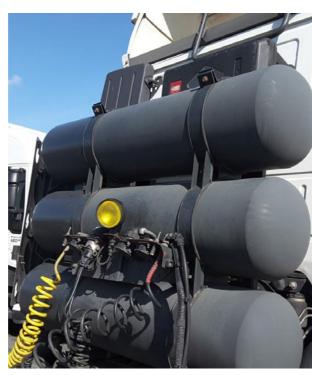
CNG CYLINDERS

CNG cylinders must be returned in proper conditions as illustrated in pictures.

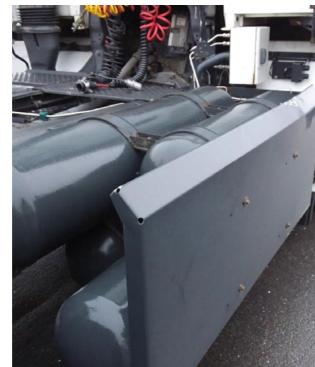
CNG cylinders must be returned in proper conditions as illustrated in pictures.

Dents, deformations, rust and/or gouges that do not affect functionality and safety are accepted.

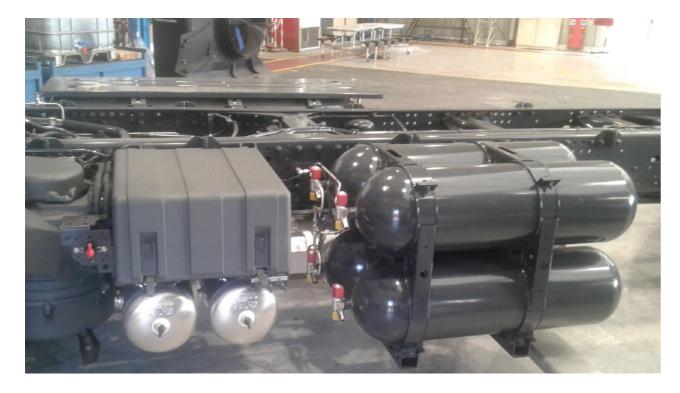
RETAINER BRACKETS AND BANDS FOR CNG CYLINDERS

CNG cylinders must be returned in proper conditions as illustrated in picture.

Check that the brackets are present and properly thighten.

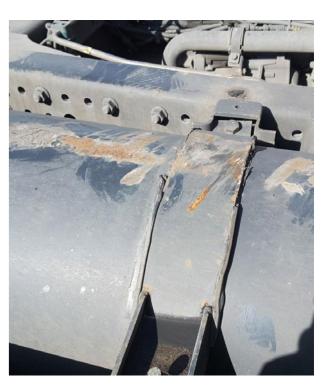
Rust, dents, breakages and/or gouges -> charge for replacement of brackets and bands.

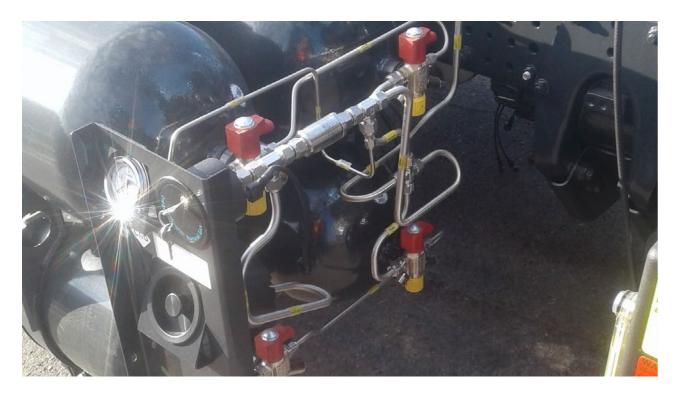
RIGID LINES FOR CNG CYLINDERS

CNG cylinders must be returned in proper conditions as illustrated in picture.

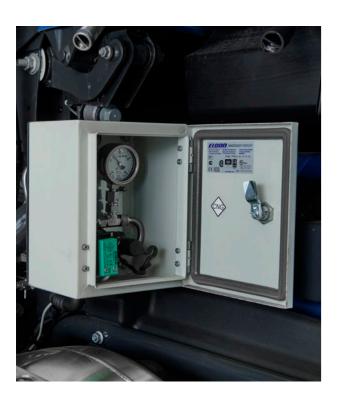
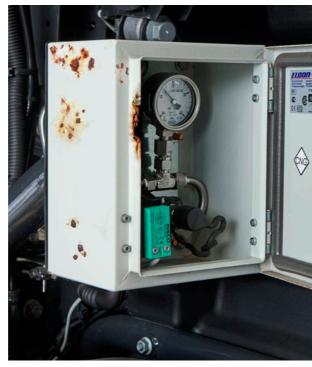
CNG FILL RECEPTACLE PROTECTION BOX

Rust on the fill receptacle protection box \rightarrow note without charge for damage.

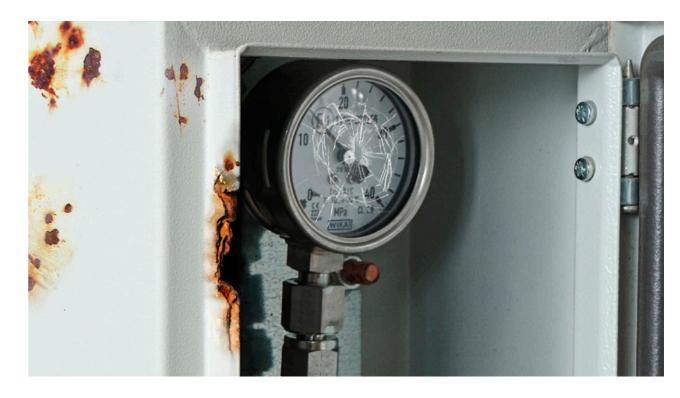
Missing protection box key, damaged CNG receptacle or pressure gauge \rightarrow charge for replacement of the full box.

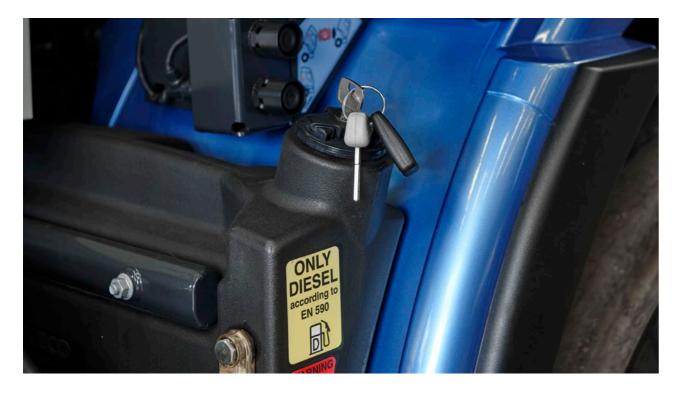
INSPECTION OF ADDITIONAL HEATER TANK

Additional heater tank must be returned in proper conditions as illustrated in picture.

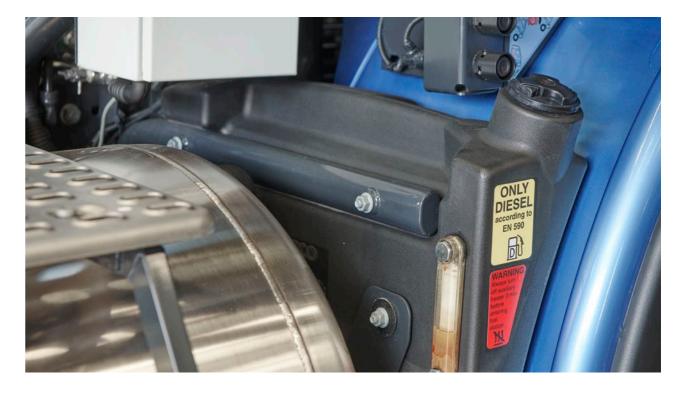
Missing additional heater tank key -> charge for replacement of key.

Breakages on the additional heater tank —> charge for replacement of the additional tank.

Level indicator shows water \rightarrow charge for replacement of the additional heater tank.
